An anniversary - 25 years of outdoor weathering of pigmented building materials

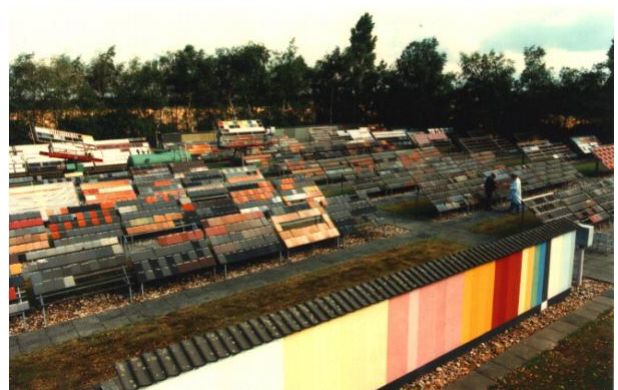
Photo 2: Krefeld weathering station

The first weathering tests at the weathering station near the Uerdingen production site (Photo 2) were carried out using paving slabs, rendering and mortar.

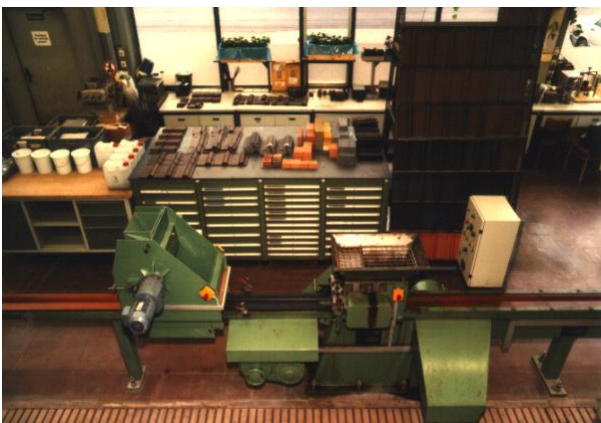
Photo 1: Concrete roof tile machine (extrusion press), Schade (1970)

A compacting machine from Rino has been available since around 1968 for the manufacture of paving slabs. Machinery from Schade for manufacturing concrete roof tiles was added in 1970 (Photo 1). This can be used to produce small, non-corrugated products.

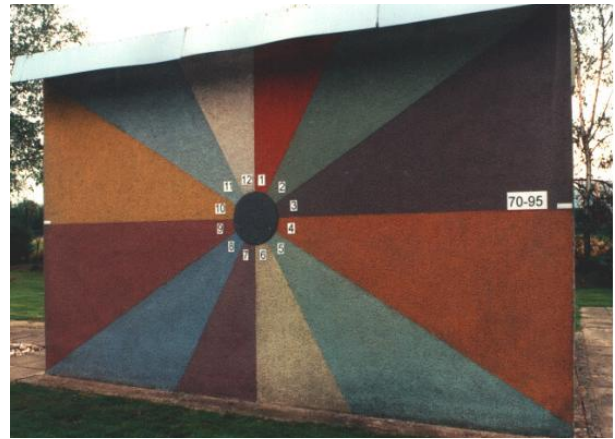
Photo 4: Mineral rendering, Weathering commenced: 1970, Photo taken: 1995

1 = 3 % Bayferrox® 110; 2 = 3 % Chrome Oxide Green GN; 3 = 3 % Bayferrox 660; 4 = 3 % Bayferrox 960; 5 = 3 % Le 70; 6 = 3 % LG 200; 7 = 3 % Bayferrox 180; 8 = 3 % Lightfast Blue 100; 9 = 3 % Bayferrox 140; 10 = 3 % Bayferrox 920; 11 = 3 % Ue 5015 (trial product); 12 = 3 % Tronox® A

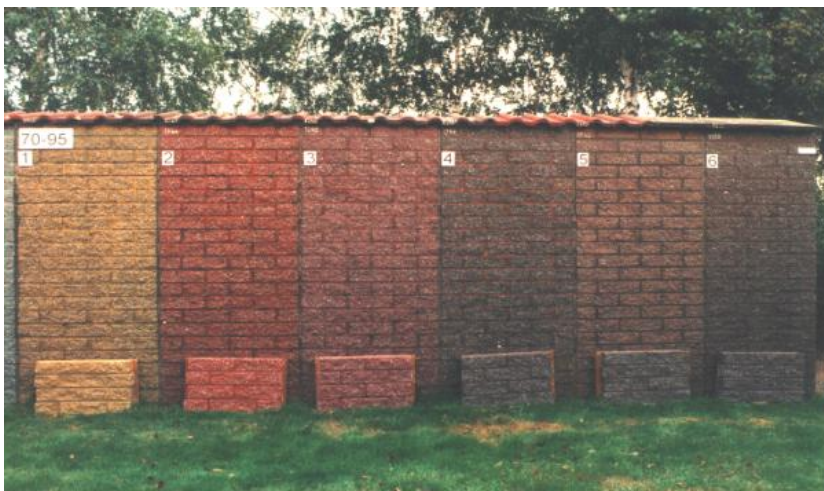
Photo 5: Concrete masonry blocks (un-weathered reference samples in foreground), Weathering commenced: 1970, Photo taken: 1995

1 = 5 % Bayferrox 920; 2 = 5 % Bayferrox 120; 3 = 5 % Bayferrox 160; 4 = 5 % Bayferrox 686; 5 = 2,7% Bayferrox 110 I Carbon Black 2 (70 : 30); 6 = 5 % Bayferrox 663

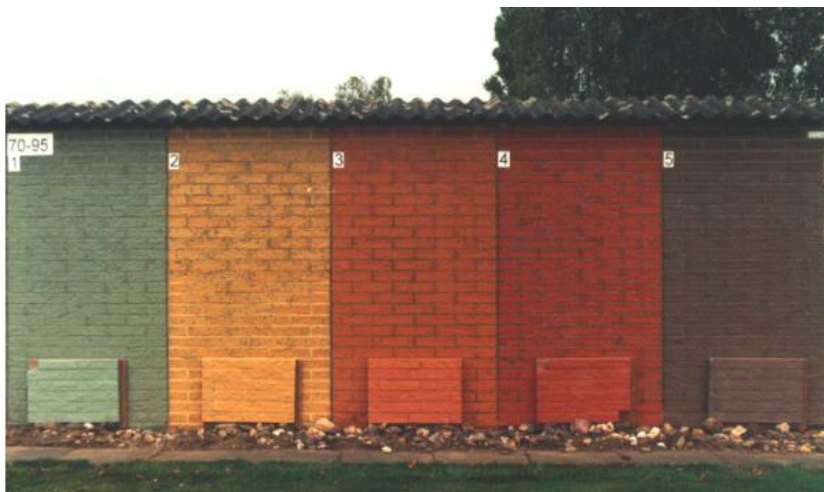
Photo 6: Calcium silicate bricks (un-weathered reference samples in foreground) Weathering commenced: 1970, Photo taken: 1995

1 = Chrome Oxide Green GN; 2 = 1 % Bayferrox 920; 3 = 1 % Bayferrox 960; 4 = 1 % Bayferrox 110; 5 = 2 % Bayferrox 660/6

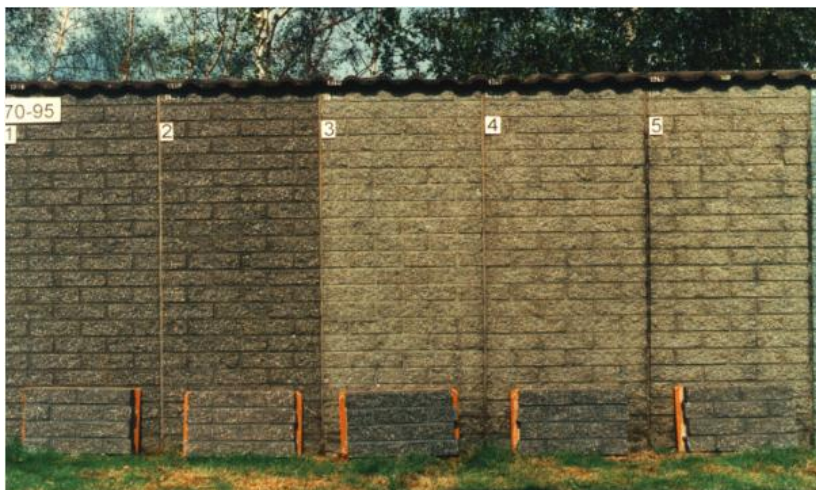
Photo 7: Concrete masonry blocks (unweathered reference samples in foreground) Weathering commenced: 1970, Photo taken: 1995

1 = 5 % Bayferrox 318; 2 = 3.5 % Bayferrox 320; 3 = 2.8 % Carbon Black 1; 4 = 1.2 % Carbon Black 2; 5 = 1.7 % Carbon Black 3

These test samples and many others allow conclusions to be drawn about the stability of the entire system and not just of the pigments used. It has been found in many cases that various pigments, for example, carbon blacks or certain organic pigments do not have adequate weather stability. Photos 7 and 8 show concrete masonry blocks and

calcium silicate brick colored with various black pigments after outdoor weathering for around 25 years. Photo 9 shows concrete pavers after outdoor weathering for two years in Den Helder, The Netherlands. The carbon black pigment used has already faded in this relatively short period of time. The most important conclusion to be drawn from this, apart from the familiar fact that certain pigments are not stable enough, is that this fading process is irreversible and not merely a temporary phenomenon.

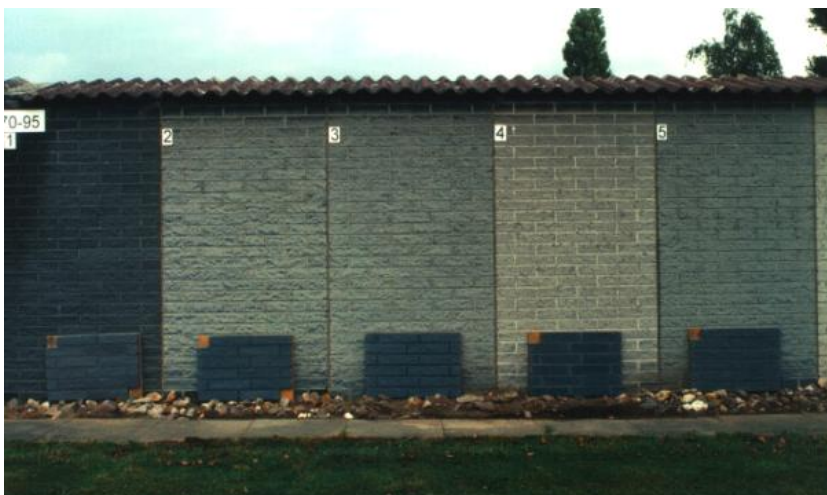
Photo 8: Calcium silicate bricks (unweathered reference samples in foreground) Weathering commenced: 1970, Photo taken: 1995

1 = 3 % Bayferrox 303 T; 2 = 1.1 % Carbon Black 1; 3 = 0.5 % Carbon Black 2; 4 = 0.9 % Carbon Black 3; 5 = 0.5 % Carbon Black 4

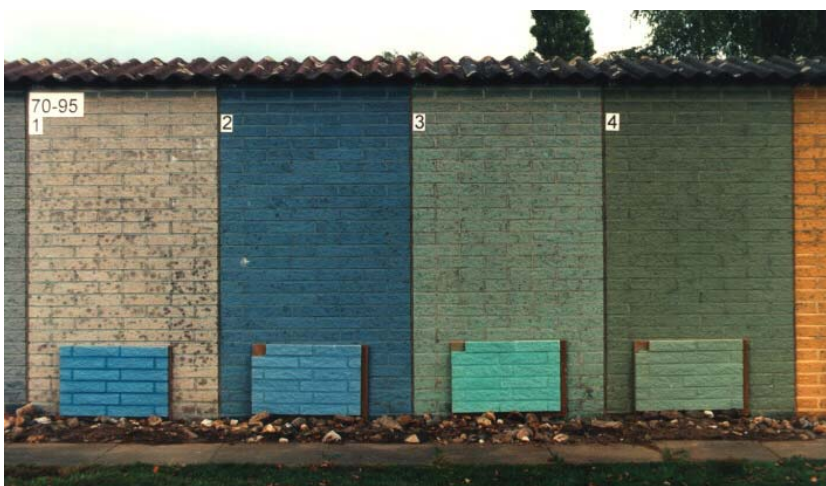
Photo 11: Calcium silicate bricks (unweathered reference samples in foreground) Weathering commenced: 1970, Photo taken: 1995)

- 1 = 0,075 % Organic Blue pigment, 2 = 1 % Lightfast Blue 100, 3 = 0,15 % Organic Green pigment, 4 = 1 % Chrome Oxide green GN

Photos 10 and 11 show various blue and green pigments used in concrete masonry blocks and calcium silicate brick and tested for their long-term stability. Here too, it can be seen that there are considerable differences in the weather stability of the various pigments. Chrome oxide green or cobalt oxide spinel blue provide durable color in the pigmented building materials. It should be pointed out again that the fading of organic pigments is an irreversible process, i.e. not merely a temporary phenomenon. Numerous authors [1, 2] have discussed this subject in great detail.

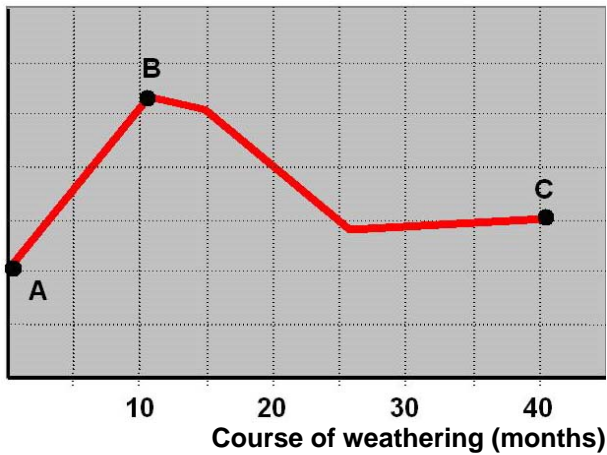
Photo 14: The individual phases of weathering in concrete roof tiles of varying composition

Weathering duration in years						
	2	5	10	15	20	25	30
Through-coloured	E	chalking — erosion					→
Unpigmented dispersion*	N	chalking — erosion					→
Unpigmented dispersion (solvent-borne)*	N	chalking — erosion					→
Pigmented cement slurry and coloured sand	E	Fungi and moss	removal of sand grains				→
Emulsion paint*	N	chalking — erosion					→
Pigmented cement slurry and emulsion paint*	N	chalking — erosion					→

* The durability is dependent on the film thickness and the binder used.
E Efflorescence
NE No efflorescence

ment and photographic documentation. This allowed conclusions to be drawn about the exact process of weathering in various building materials over the course of a number of decades. Photo 14 shows the individual phases of weathering in concrete roof tiles of varying composition.
